Fax Transmission

Re: Brix Historical Drainage Pattern Review Total No. of Pages Including Cover: 4

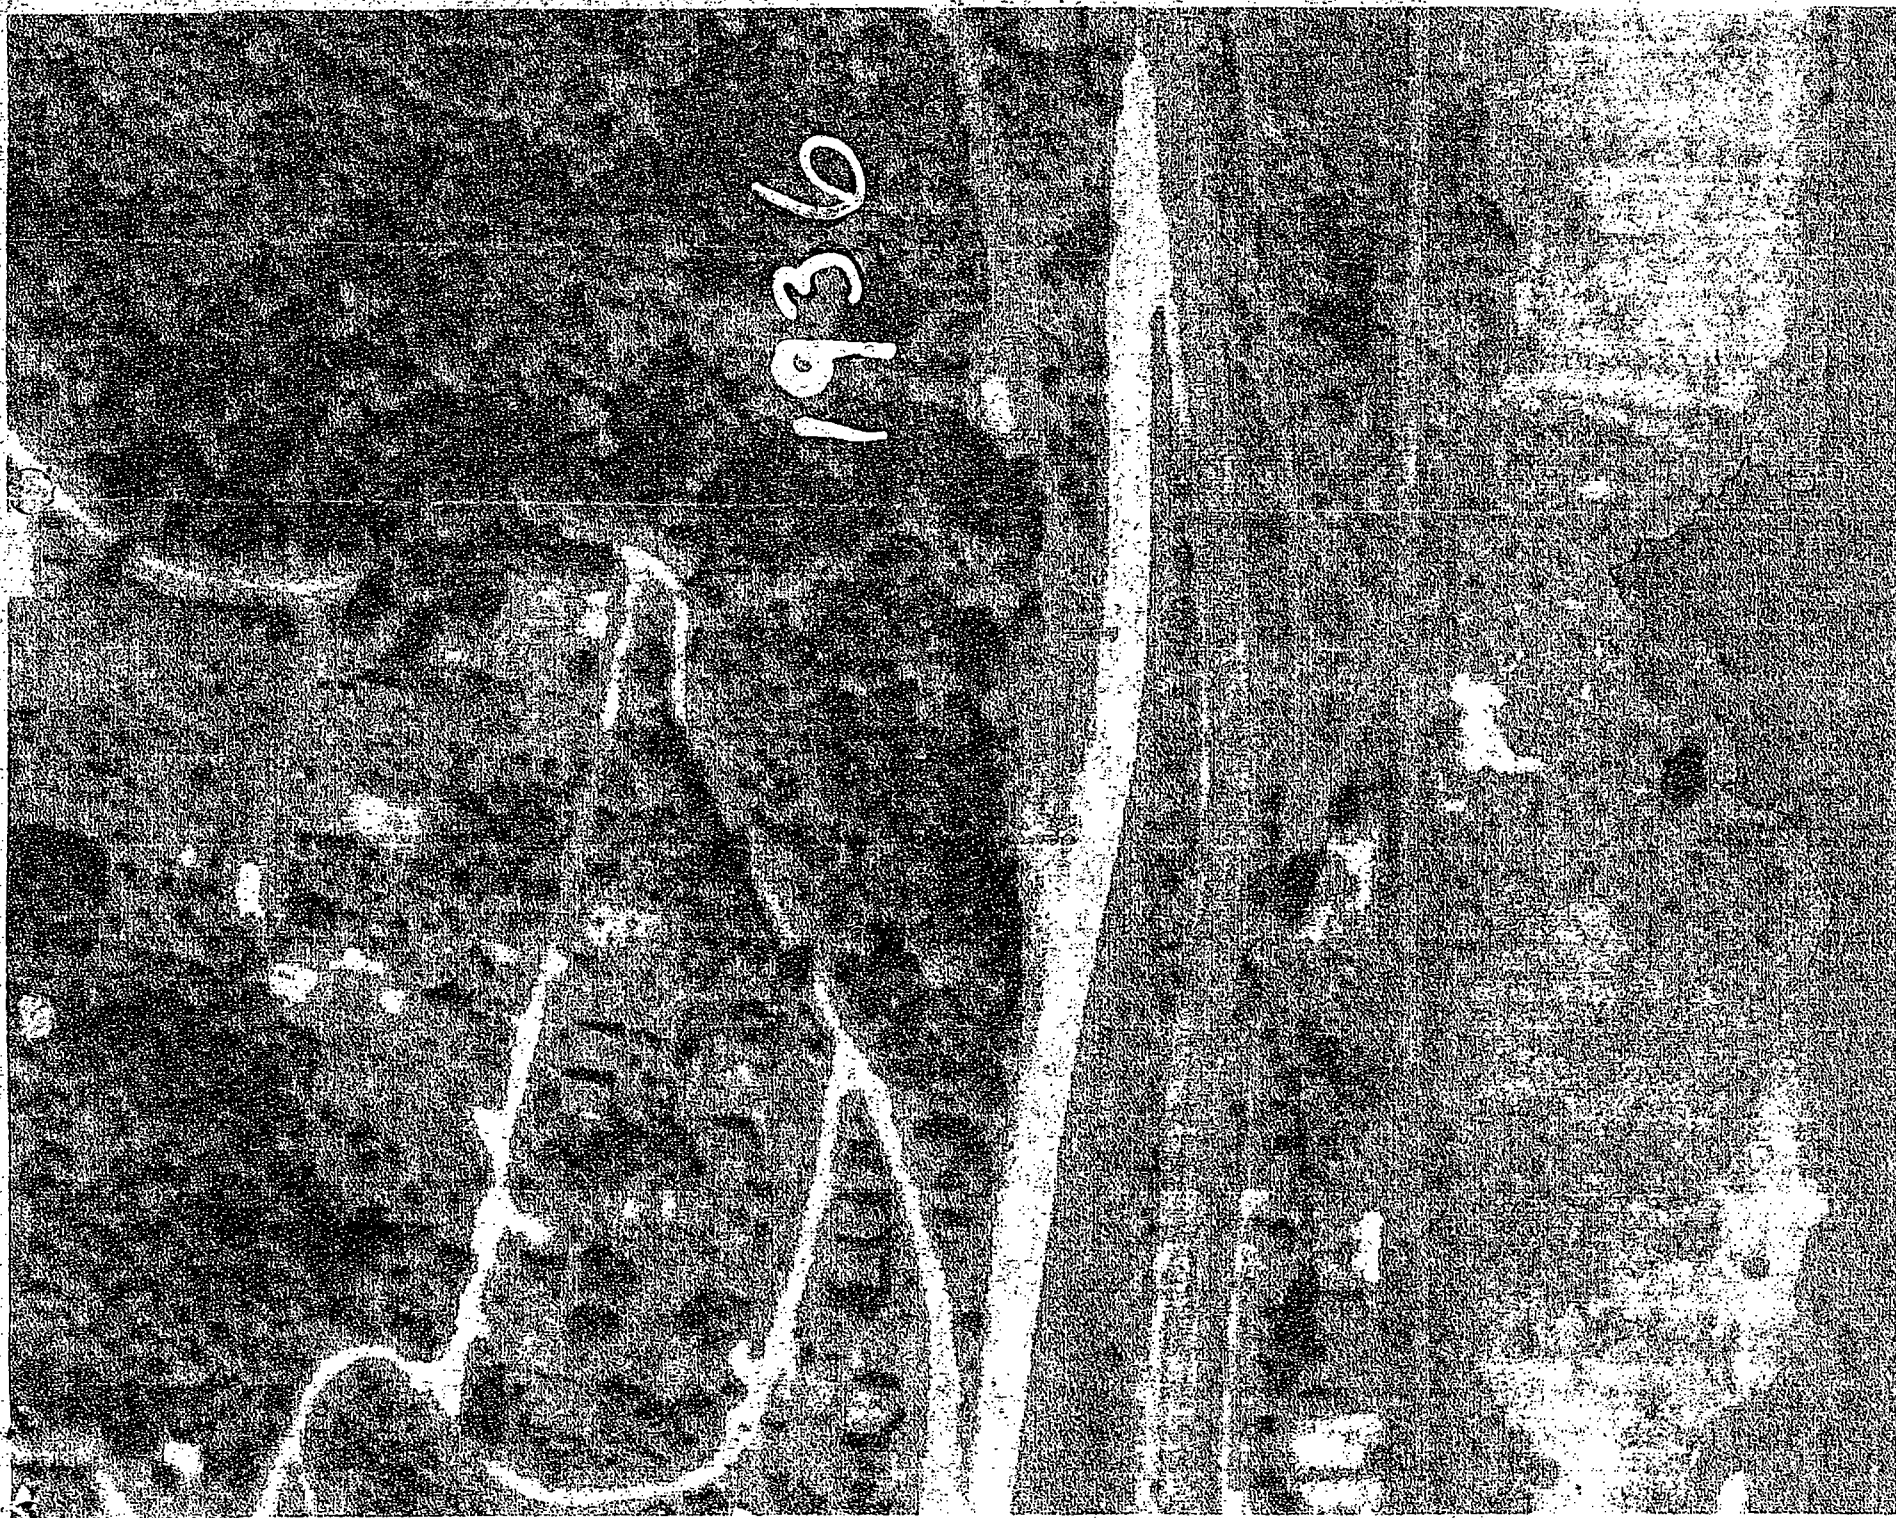
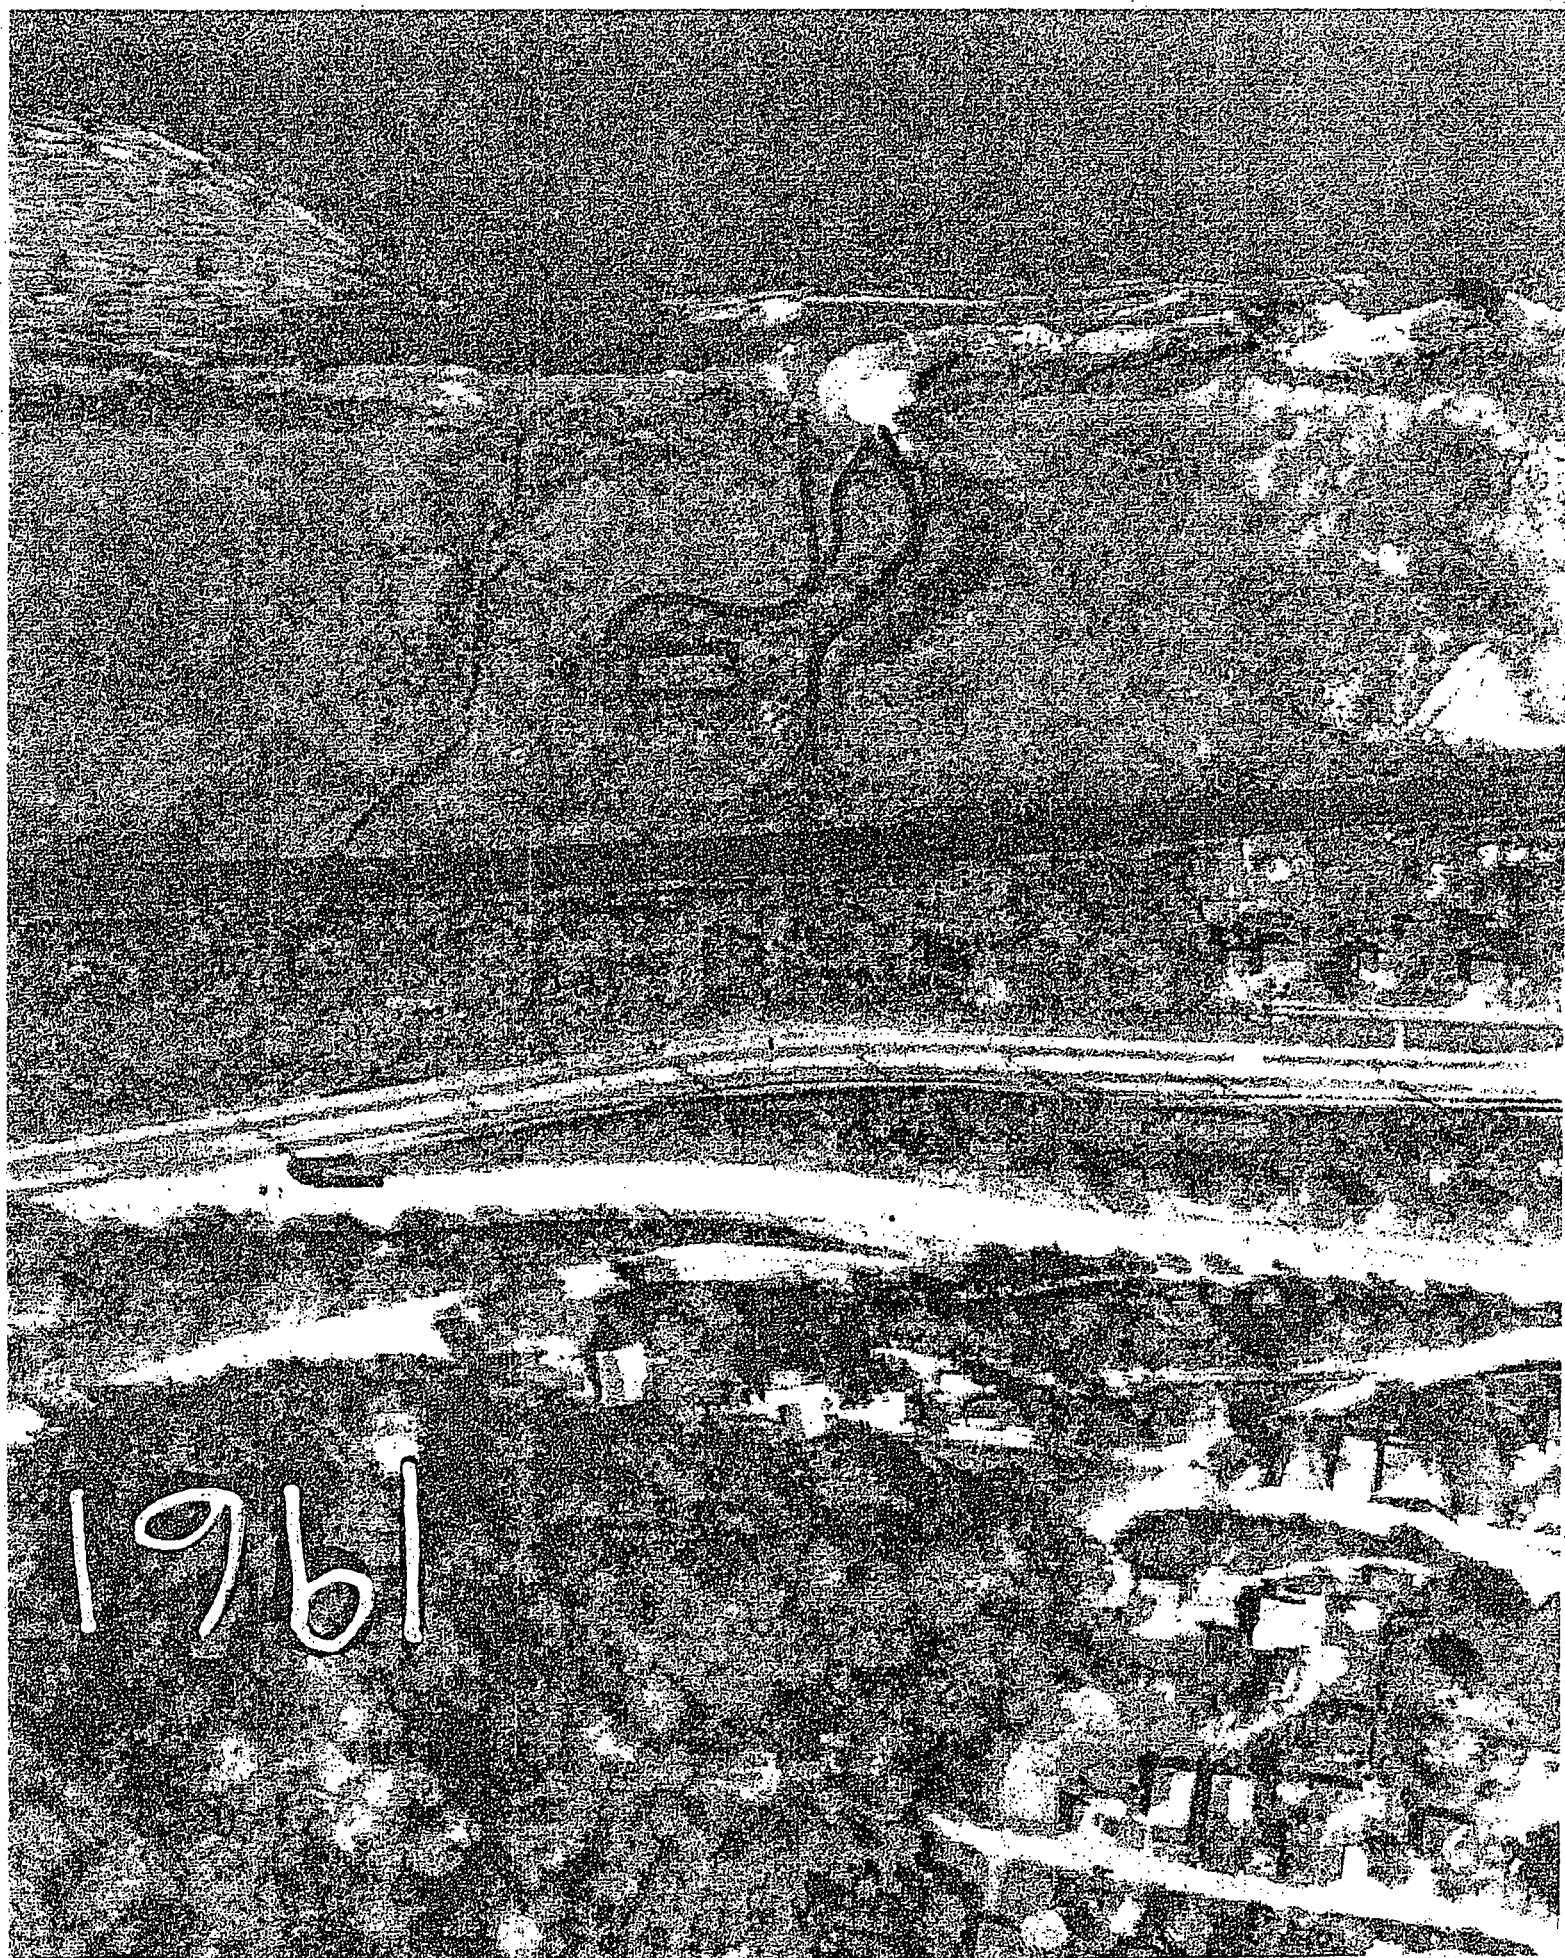
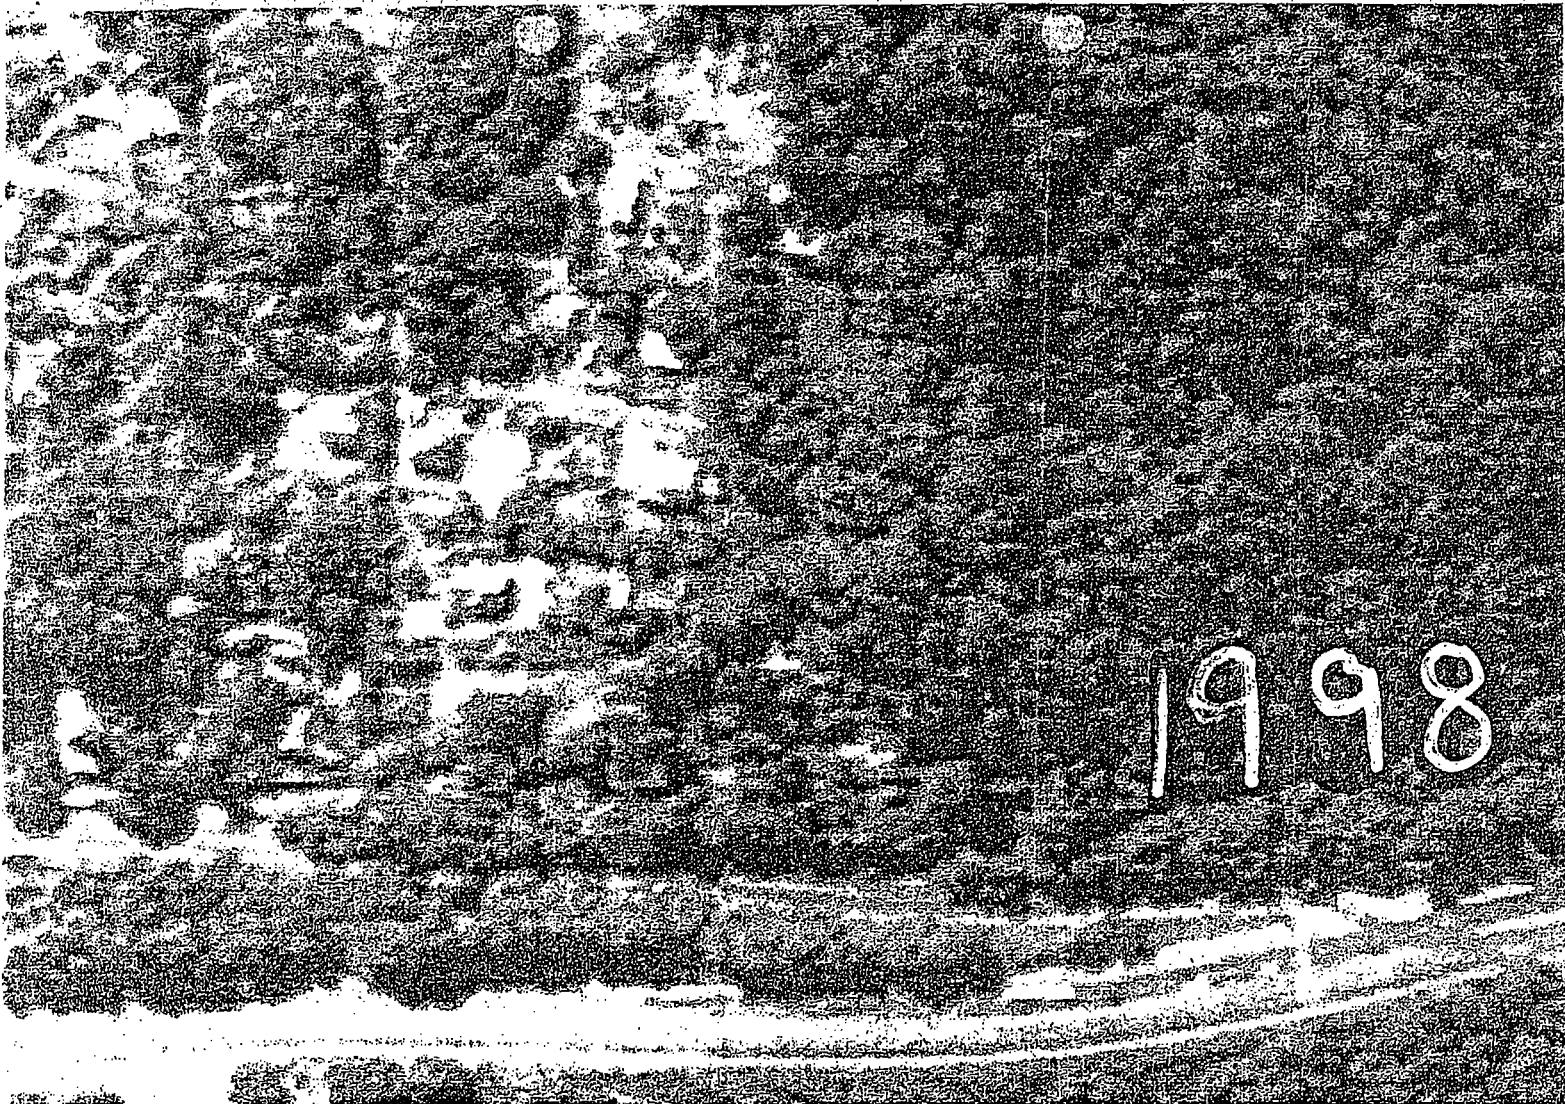
We reviewed the 1961 aerial photo, traced and overlaid 1961 site features on the 1998 aerial photo. We could not get an exact match due to the slight variation in the angle of the photo. Note that the drainage pattern in 1961 does not represent natural topography, but rather post fill conditions. Please refer to 1936 aerial photo that shows a small shoreline embayment. The embayment is filled by the time of the 1961 photo. Using the 1998 photo with the 1961 drainage pattern overlay, it appears that the proposed site of monitoring well MW-4 should be in a good location to address this potential migration pathway.

I have the 1961 and 1998 aerial photographs with overlays in Corel Draw format. I could send these electronically, but they are huge (10-12 meg each). I also have the aerial photos in JPEG format without the overlays (0.5 to 1 meg each).
